PARACHUTE RECOVERY SYSTEM

RECORDER CAPSULE

FINAL REPORT

NO. 8 (FEBRUARY 7, 1966)

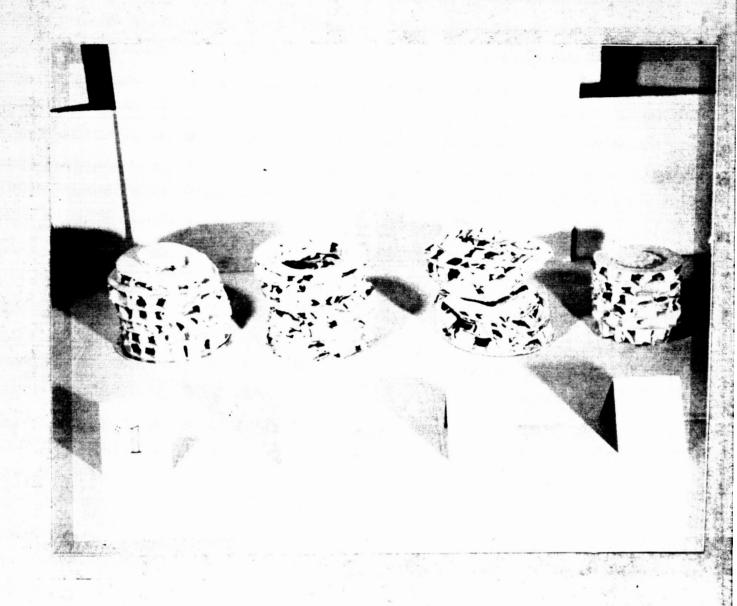
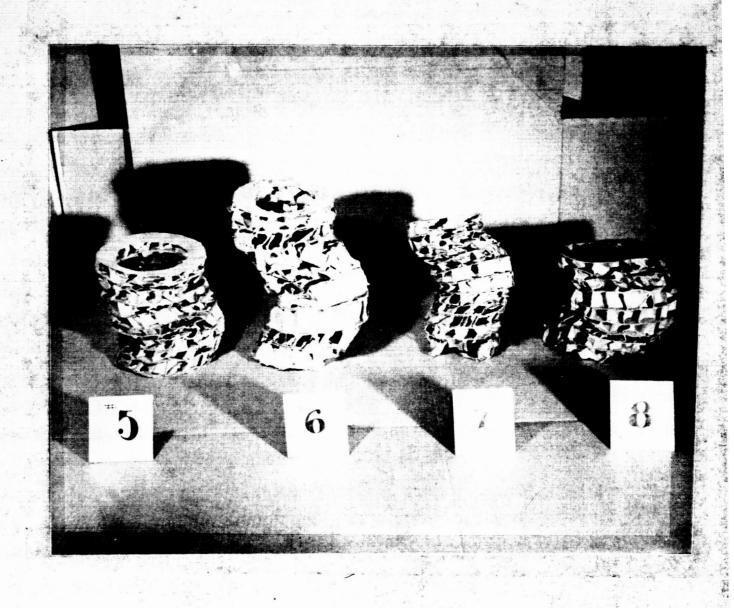
of lengthening the configuration, the column failures resulted. Also, Figure 5 and Figure 6 shows specifically the configurations used for the results shown for Charts #1 through #8. Test #1 shows that the configuration caused impact to exceed 16 g's, requiring a "softer" configuration in the form of length and less effective cross-section. Test #7 shows the results of the "softer" configuration wherein initial "g" impact was less than 10, but that column failure and subsequent "bottoming out" caused a peak impact in excess of 10 g's, followed by considerable rebounding before stabilization.

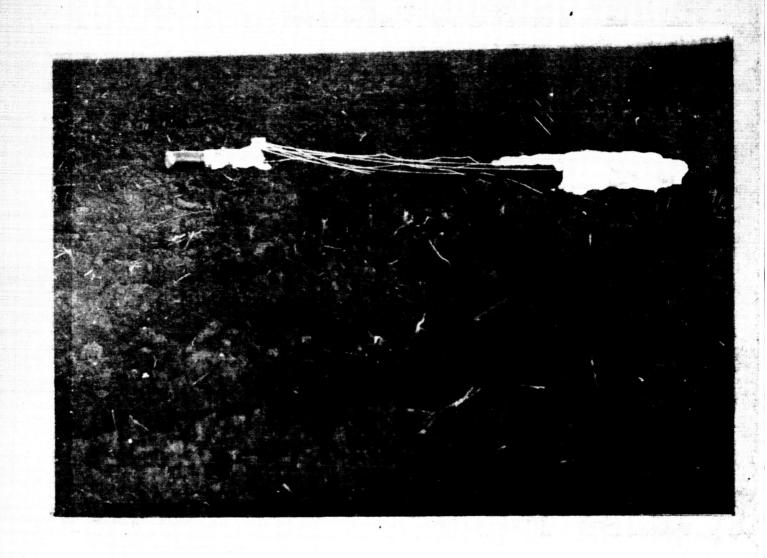
FIGURE 33
MODIFIED RECORDER CAPSULE ASSEMBLY

Impact as observed and cerified by Reels A and B of the movie film was essentially as theoretically intended. In spite of the horizontal drift rate of the assembly, impact attitude appeared to permit performance of the nose cone as desired. After collapse of the nose cone, the assembly was not dragged, but toppled by its own weight within its own length with the parachute gently collapsing to one side away from the Capsule. See Figure 33.

Damage to the Capsule was limited solely to a bent tail fin which was easily corrected. Condition of the nose cone was such that it is to be considered a reusable component.

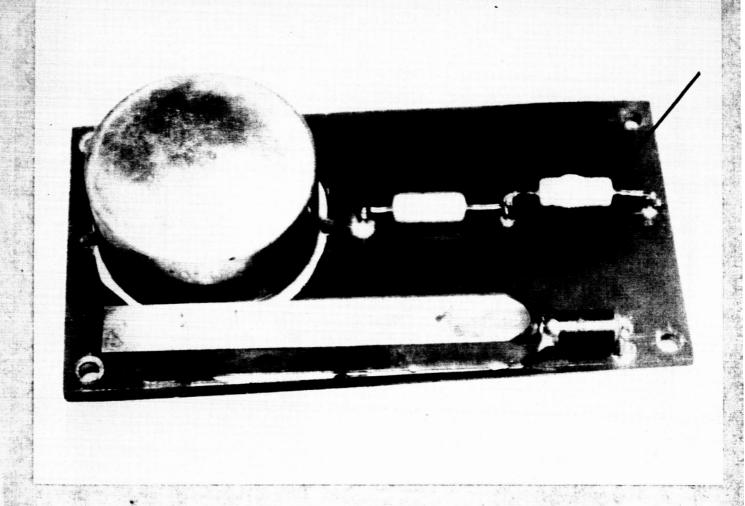
FIGURE 36 DUMMY RECORDER CAPSULE ASSEMBLY COMPONENT BOARD

Following these tests at SPACE Corp. the pyrotechnic time delay relay with the shorted squib end was returned to the vendor for evaluation. Evaluation was also requested regarding "apparent" short firing time; less than 15 seconds plus or minus 20%. Atlas Chemical Industries letter of December 16, 1965 with accompanying test report and letter of February 9, 1966 are included in this report as favorable evidence that the relays operated correctly with the exception of the squib end shorting which was indicated to SPACE Corp. to be possible as occurred but would be a rare repetition. It should be noted that because of the sequence function of the 3 OHM resistor in the actual Modified Capsule, any shorting of the squib end of the time delay relay would have no affect on any part of the circuitry so as to cause a malfunction. In the actual Modified Capsule upon ejection from a vehicle, the circuit experiences only a momentary "starter" electric signal to this circuit and not a prolonged signal or voltage required by the Dummy Capsule impact recorder drive motor. Other than its affect on the Dummy Capsule drop test for this one case, the actual Modified Capsule is totally unaffected.
